83 y/o old female with neck pain

Allan Zhang DO

Type II odontoid fracture

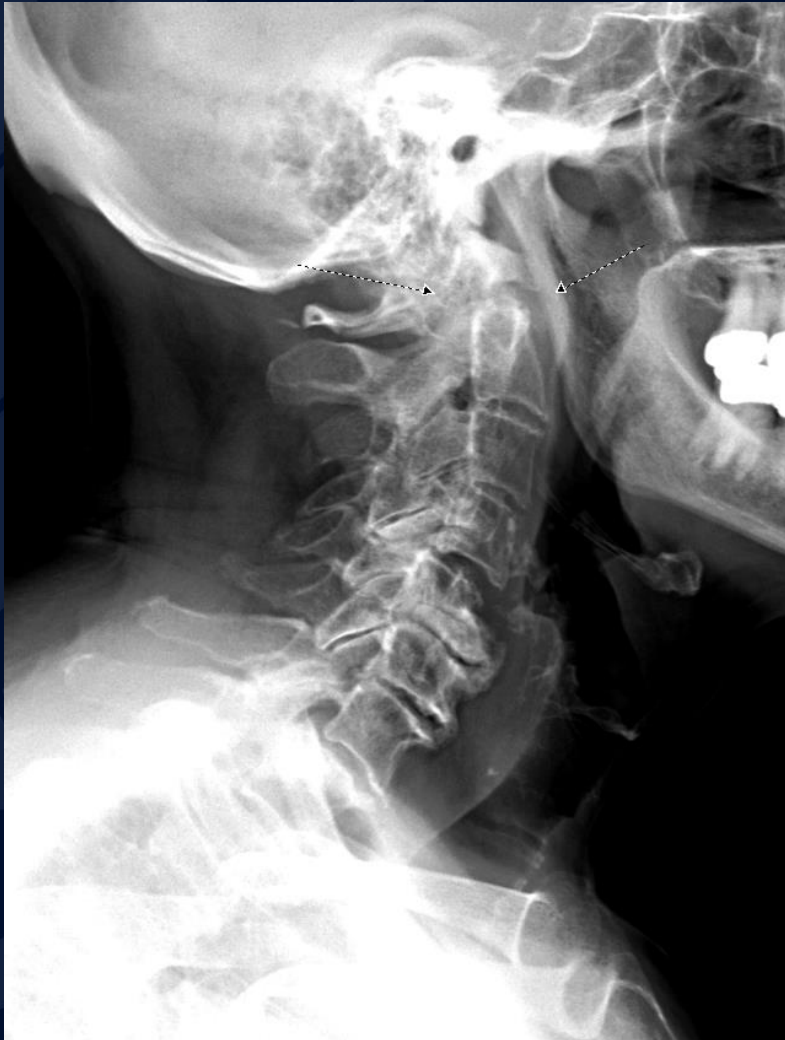
- On the lateral view, there is posterior subluxation of C1 relative to C2 of approximately 8 mm.
- The tip of the odontoid process is not well visualized.
- Recommend CT for further eval

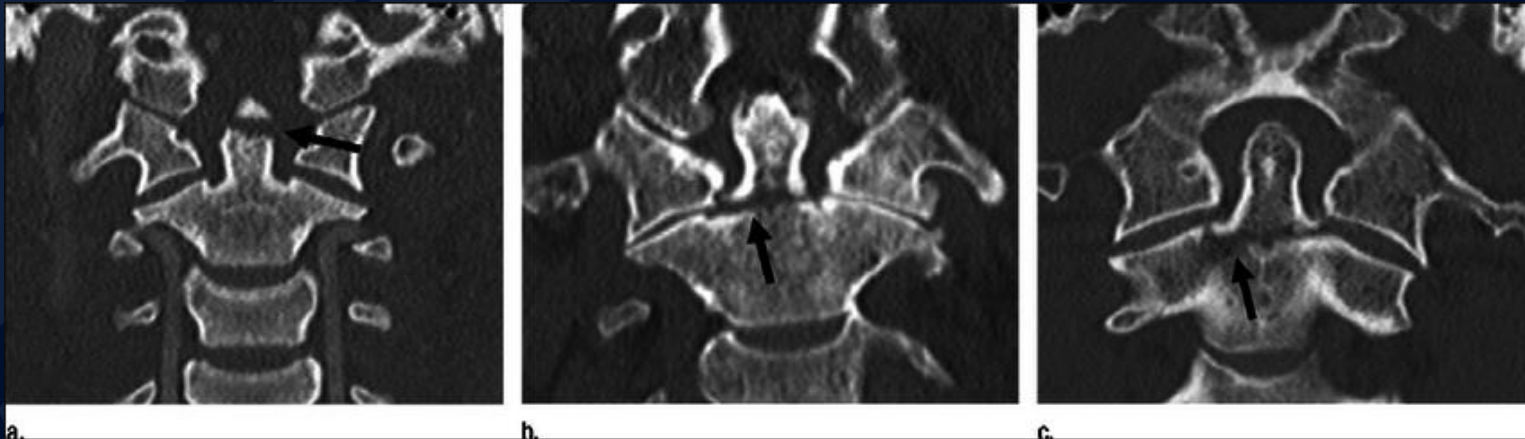
Type 1: fracture of the upper part of the odontoid peg

Type 2: fracture at the base of the odontoid
-most common
-unstable
-high chance of nonunion

Type 3: through the odontoid and into the lateral masses of C2

- Treatment: fracture pattern dictates management
 - Type I fracture
 - Usually stable injury
 - Treated with simple immobilization
 - Type II fracture
 - Most likely to progress to nonunion
 - Surgical fusion may be necessary to achieve stability
 - Type III fracture
 - traction followed by bracing
