# 30 y/o male with acute left wrist pain

# Scaphoid Fracture

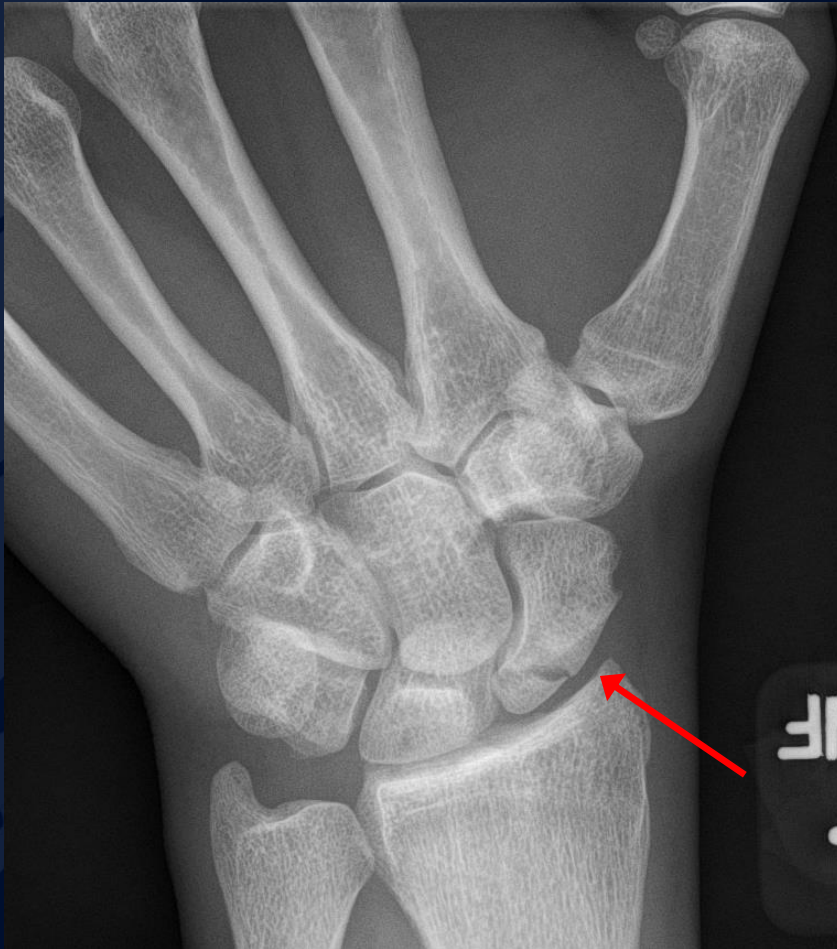
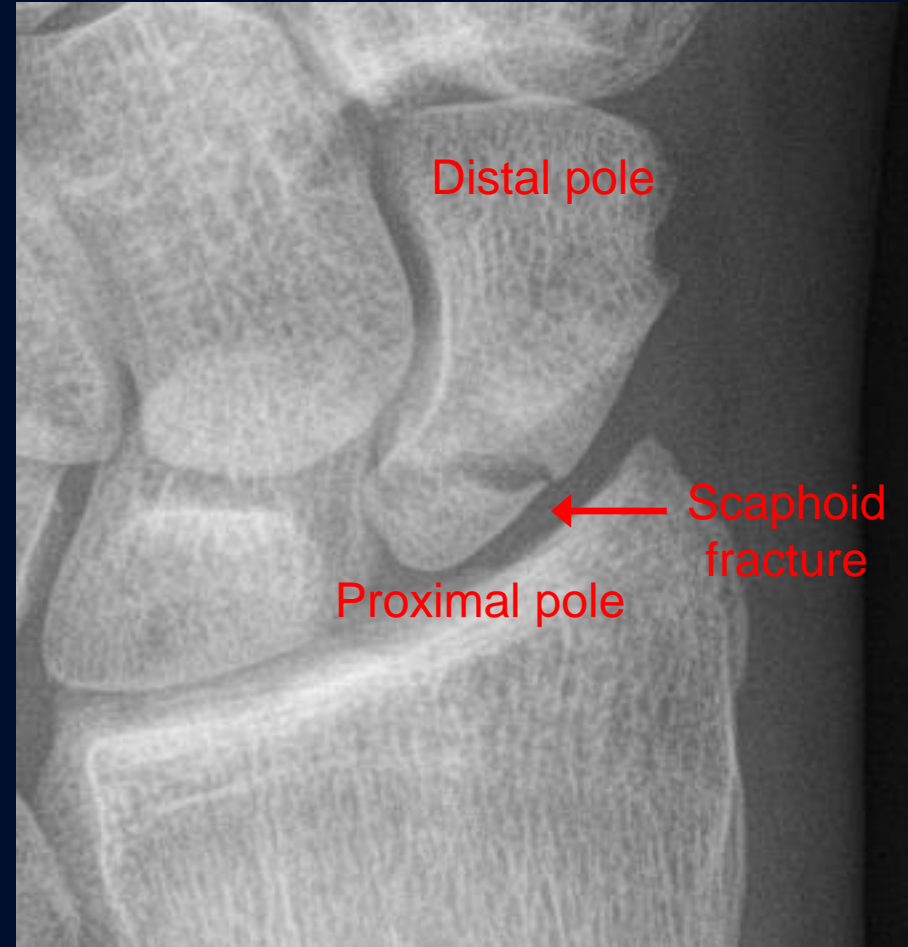
# PA radiograph

- PA x-ray showing transverse scaphoid fracture.

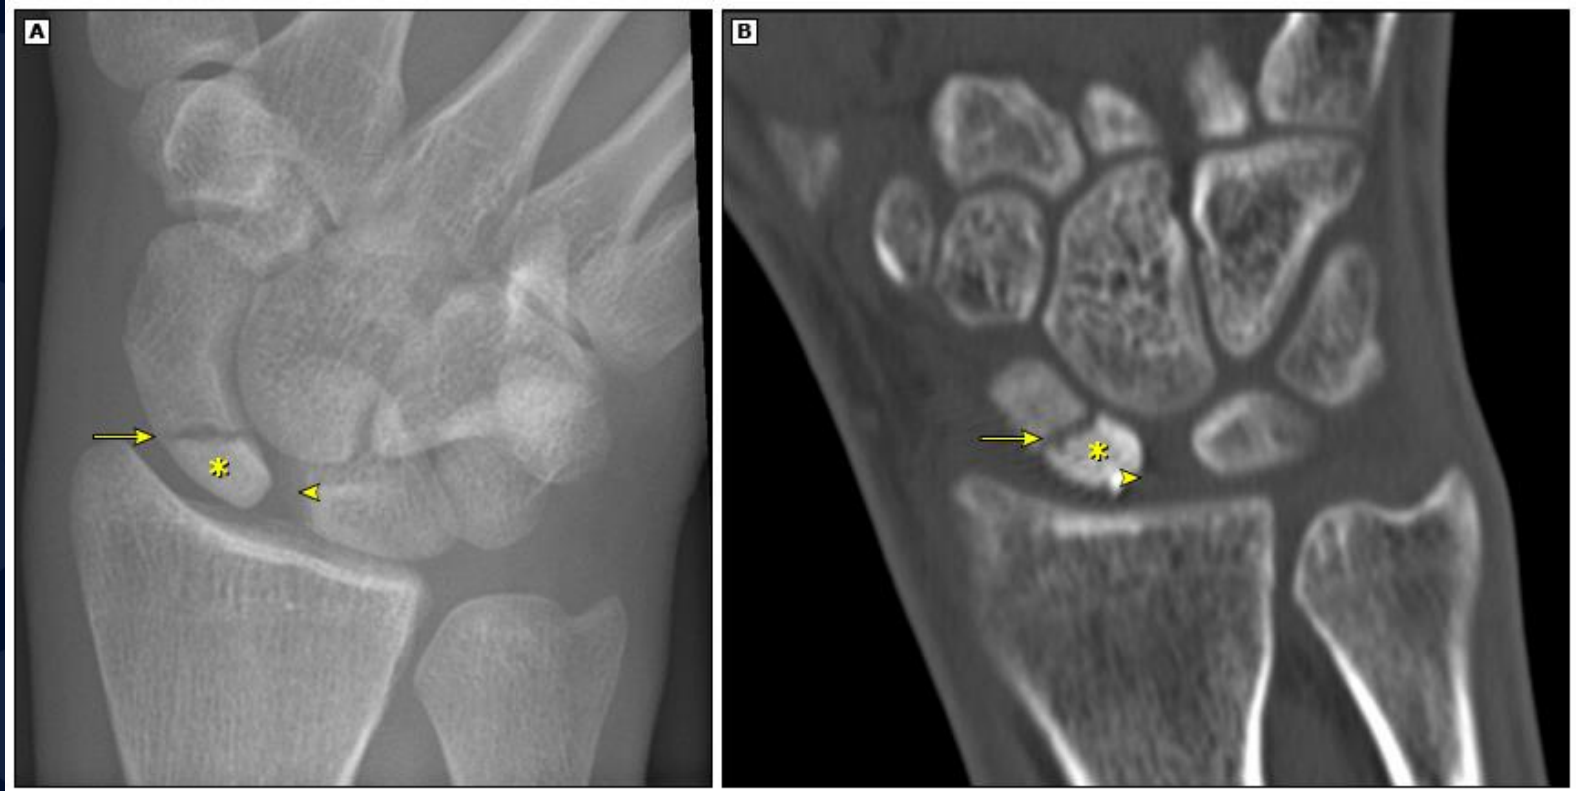
# Avascular necrosis/Nonunion

Scaphoid view radiograph (A) and CT scan (B) showing nonunion (arrow) and avascular necrosis (asterisk) and the Terry Thomas sign – scapholunate ligament injury (arrowhead).
